8 June 2011

## **ASX Announcement**

## SECOND PHASE DRILLING PROGRAM COMMENCES AT THE DINAMARQUESA PROJECT

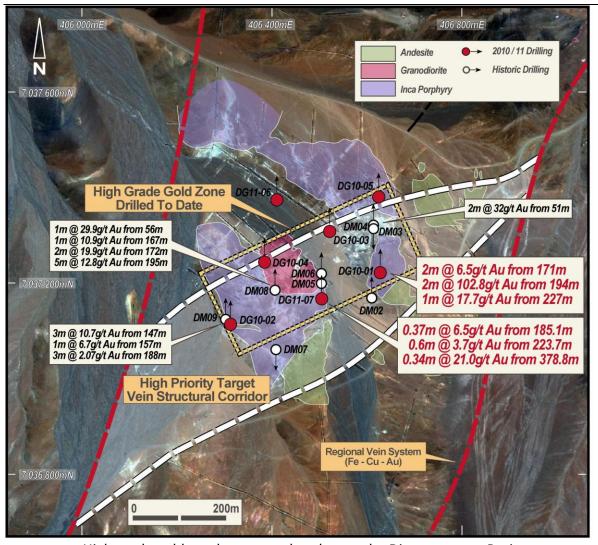
High grade gold results returned to date at the Dinamarquesa Project

Genesis Minerals Limited (ASX:GMD) is pleased to announce it has commenced a second phase drilling program at its Dinamarquesa Project in northern Chile. A 5,000m drilling program will target high to bonanza grade quartz veins within the 1.2km long east north east trending structural corridor defined to date. The program will follow-up results from recent drilling which returned (GMD ASX Releases 18-01-2011 and 18-02-2011) very high grade gold intersections including:

- 2m @ 102.8 g/t gold,
- 2m @ 6.5 g/t gold,
- 1m @ 17.7 g/t gold, and
- 0.34m @ 21.0g/t gold

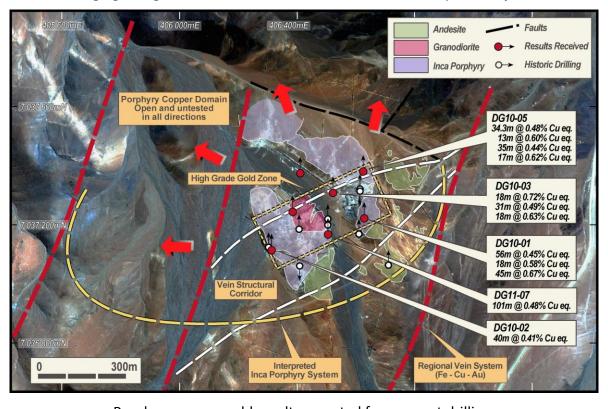
Porphyry copper gold results reported from recent drilling.

Drilling will also target the porphyry copper-gold system at the Dinamarquesa Project where the initial drilling program returned broad intersections of copper-gold-molybdenum mineralisation and confirmed the potential for a large porphyry copper-gold system.
